# Before & After

A series of conservation projects with before & after images showing how Iowa NRCS and our partners help private landowners address natural resource concerns on their land

United States Department of Agriculture  
Natural Resources Conservation Service  
Helping People Help the Land

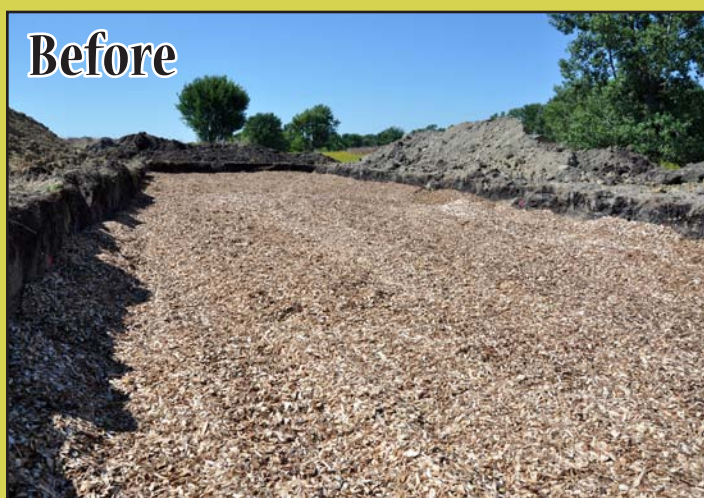
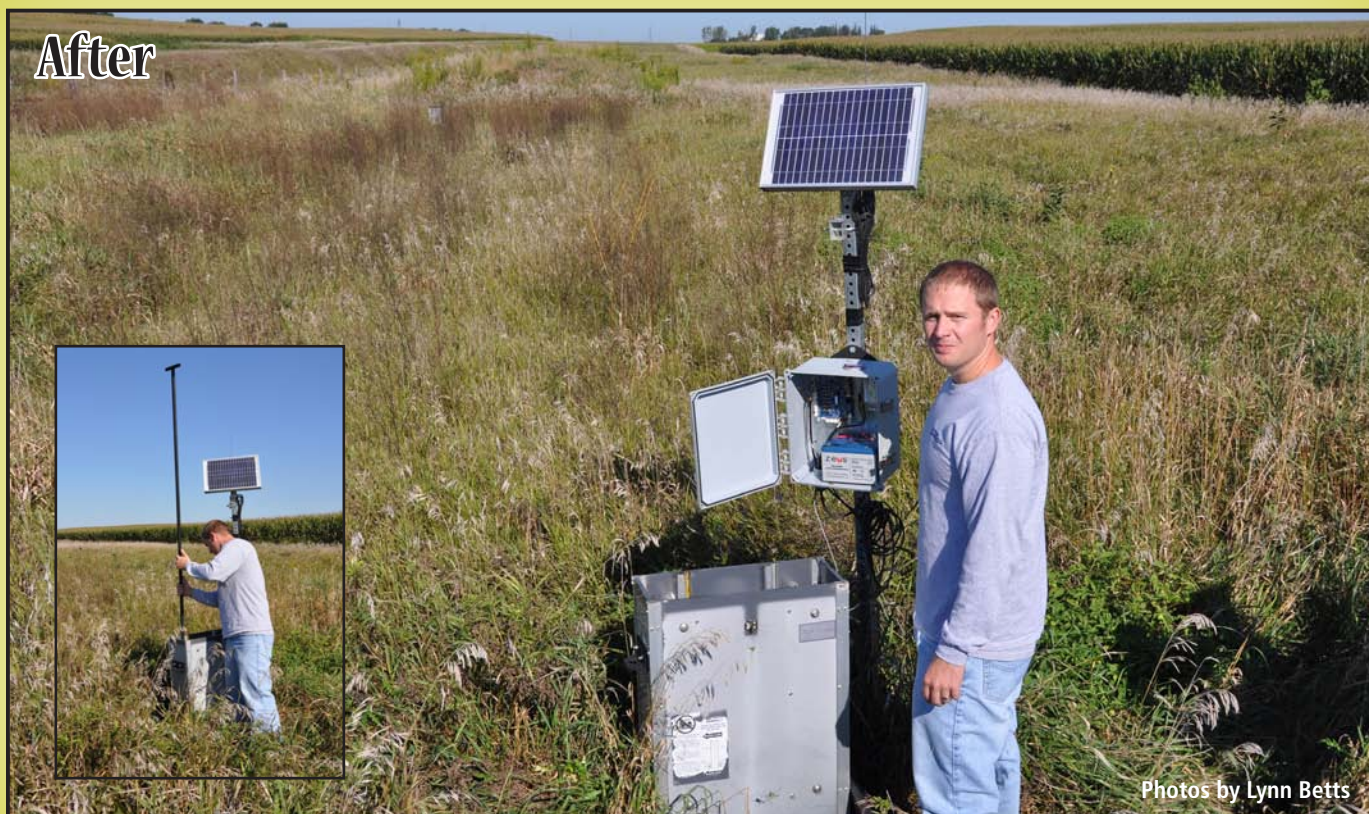
# Denitrifying Bioreactor/Water Monitoring

Denitrifying bioreactors are underground structures filled with wood chips that intercept and treat tile water. They help reduce nitrate levels in water leaving agricultural land. The newly constructed bioreactor at left is about 3,900 square feet.

Hamilton County farmer Arlo Van Diest has two bioreactors – one installed by the Iowa Soybean Association (ISA) and another through USDA-NRCS. Both are helping improve water quality where there is concentration of nitrogen of subsurface, or ground, water. Keegan Kult (below) monitors the ISA installed bioreactors regularly for water quality.

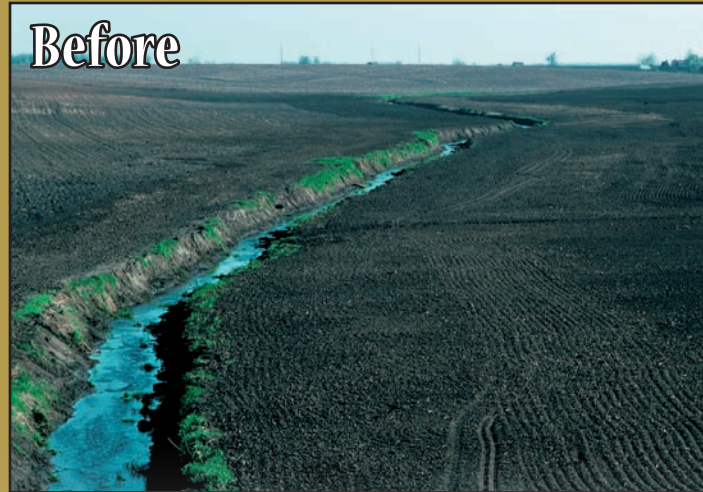
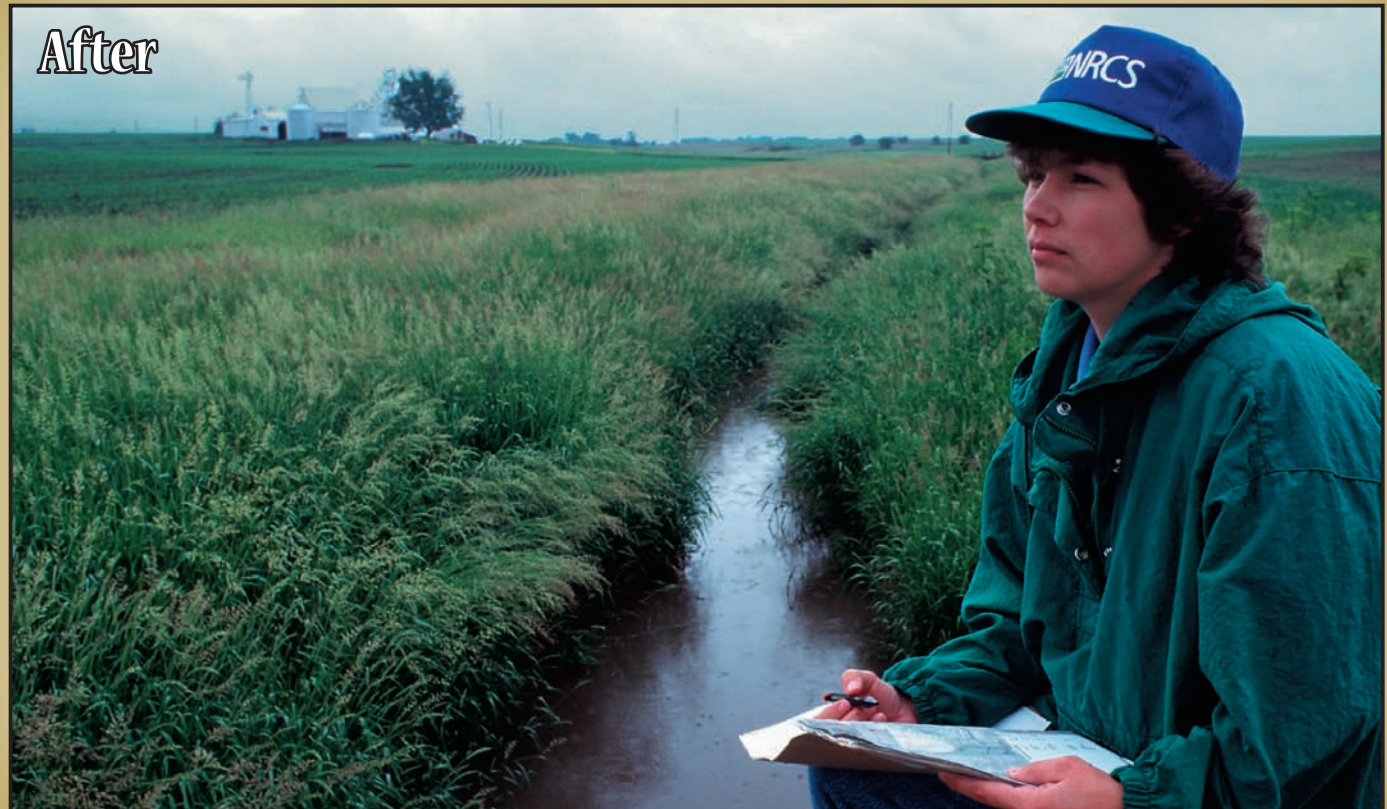
# Filter Strip

**Background:** The number one water pollutant in Iowa is sediment, and a lot of that comes from runoff from adjacent cropland. Along with a high residue management system, several other conservation practices can help crop producers reduce the amount of sediment running into adjacent streams. Practices such as terraces, contour buffer strips, and grassed waterways can reduce in-field erosion. A final stop-gap to keep sediment and other pollutants from water is a filter strip - an area of vegetation along a water course used to reduce pollutants from runoff to improve water quality.

**Success:** The landowner installed a filter strip along Cedar Creek in 1995. He is seeing improved water quality and more wildlife in the area.

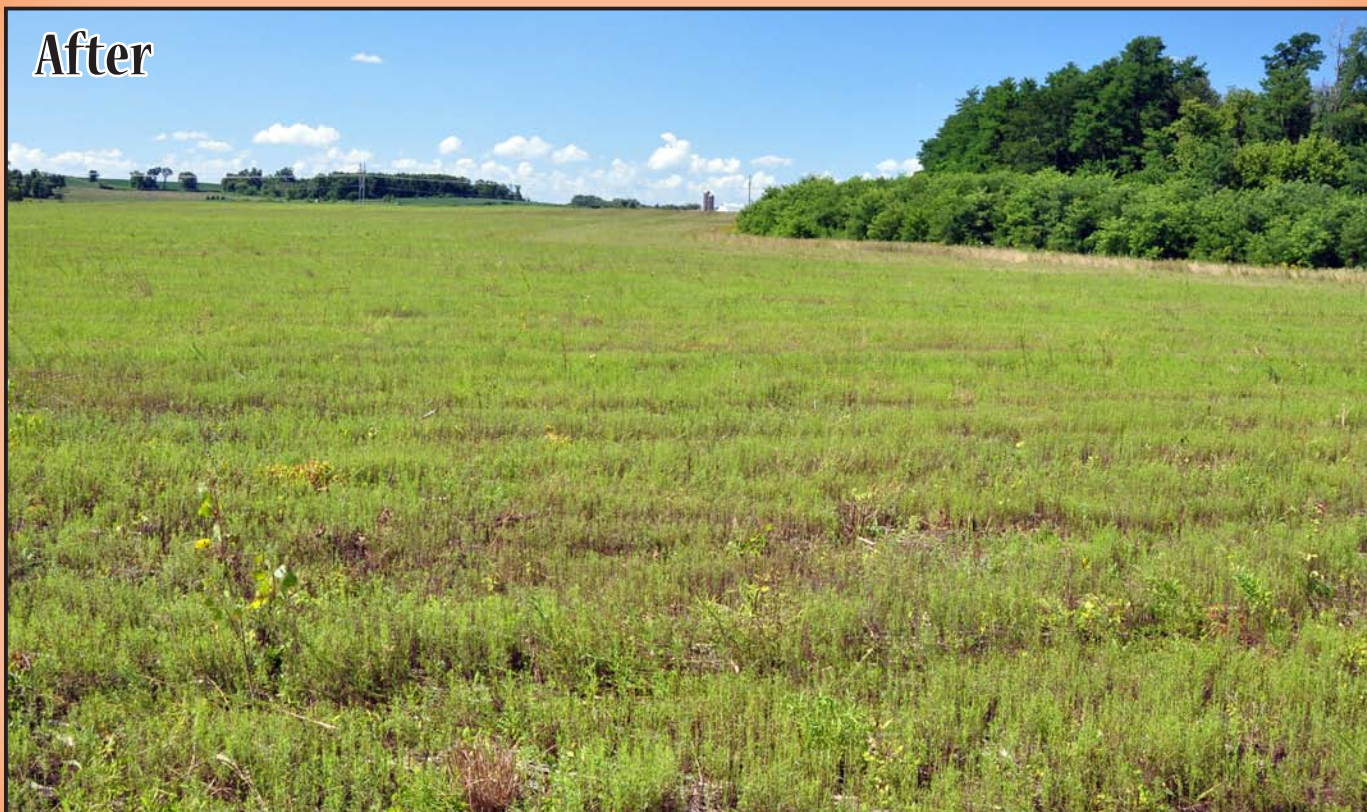
# Floodplain Restoration

**Background:** Craig Byers experienced flooding more years than not on his 480-acre cropland that sits in a floodplain near the Cedar River. Flooding meant sediment delivery to the nearby river and, oftentimes, a ruined crop. So when the USDA offered to place the flood-prone cropland into a permanent easement, Byers took the offer.

**Success:** Restoration work on Byers' cropland consisted of drilling in a native seed mix that fits the local ecosystem. If that land floods now, the floodwater will slowly recede back into the river without causing damage to the environment, infrastructure or valuable crops. The native grasses in floodplains also serve as good habitat for wildlife.

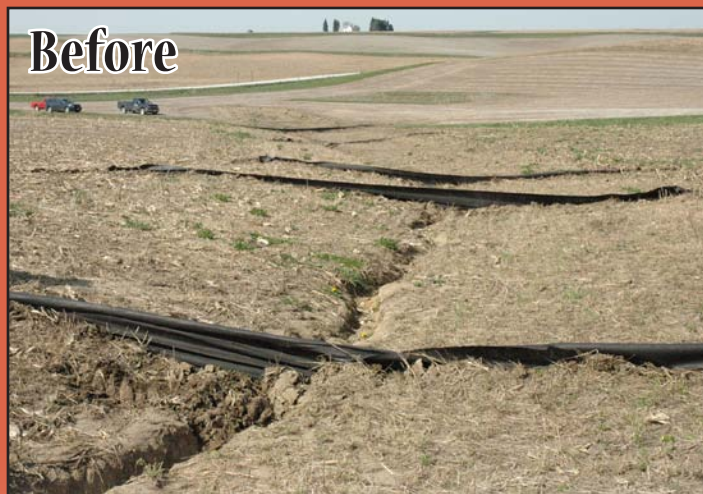
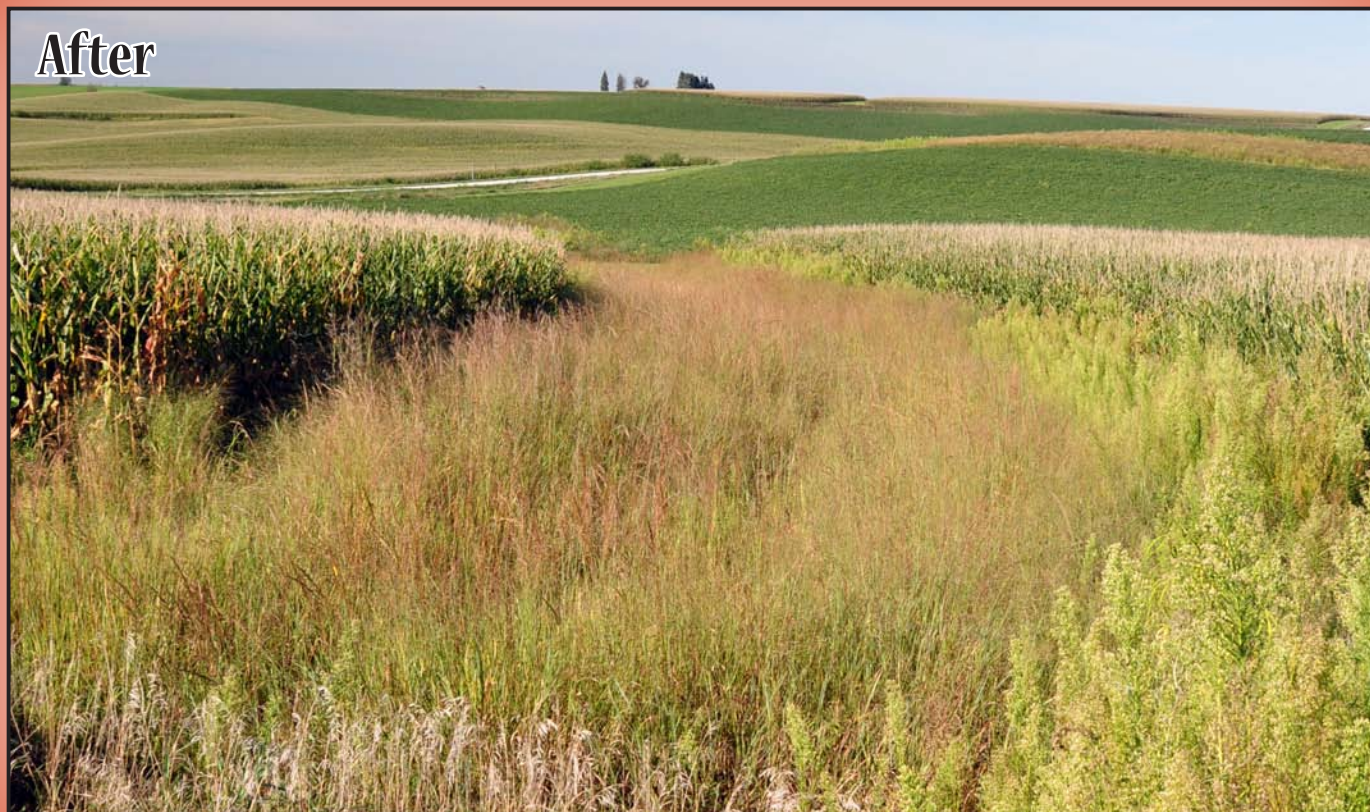
# Grassed Waterway

**Background:** A gully formed in cropland at Iowa State University's Armstrong Research Farm near Lewis. Gully erosion is caused by areas of concentrated flows of water down a slope. One of the best conservation practices to fix gully erosion is a grassed waterway.

**Success:** To combat the gully, the Armstrong Research Farm crew seeded down a grassed waterway of permanent vegetative cover. Waterways are designed in a parabolic, or dish, shape wide enough and deep enough to carry peak runoff from a 24-hour storm. Following installation, fabric checks were installed to help control ephemeral gully erosion. Fabric checks are required on all NRCS-funded waterway installations in the East Pottawattamie Soil & Water Conservation District (SWCD).

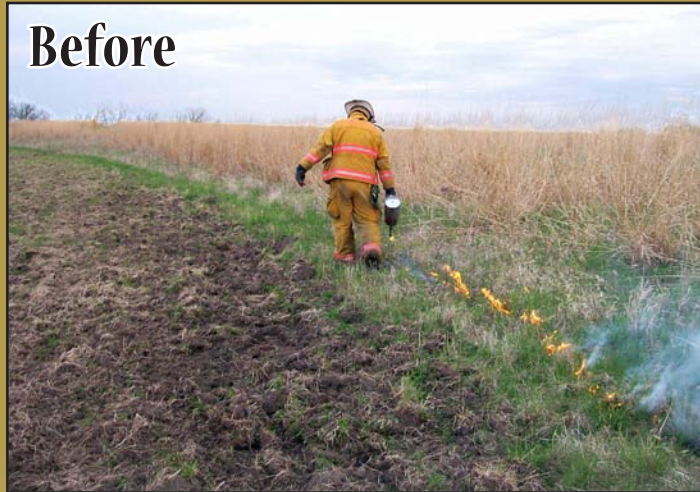
## Before

**Background:** The landowner worked with the local fire department to implement a prescribed burn on his tall grass prairie CRP land. (The Farm Service Agency requires mid-contract management, such as a prescribed burn, during the CRP contract.) His goal was to control the invasion of cool season introduced species and some woody plants.

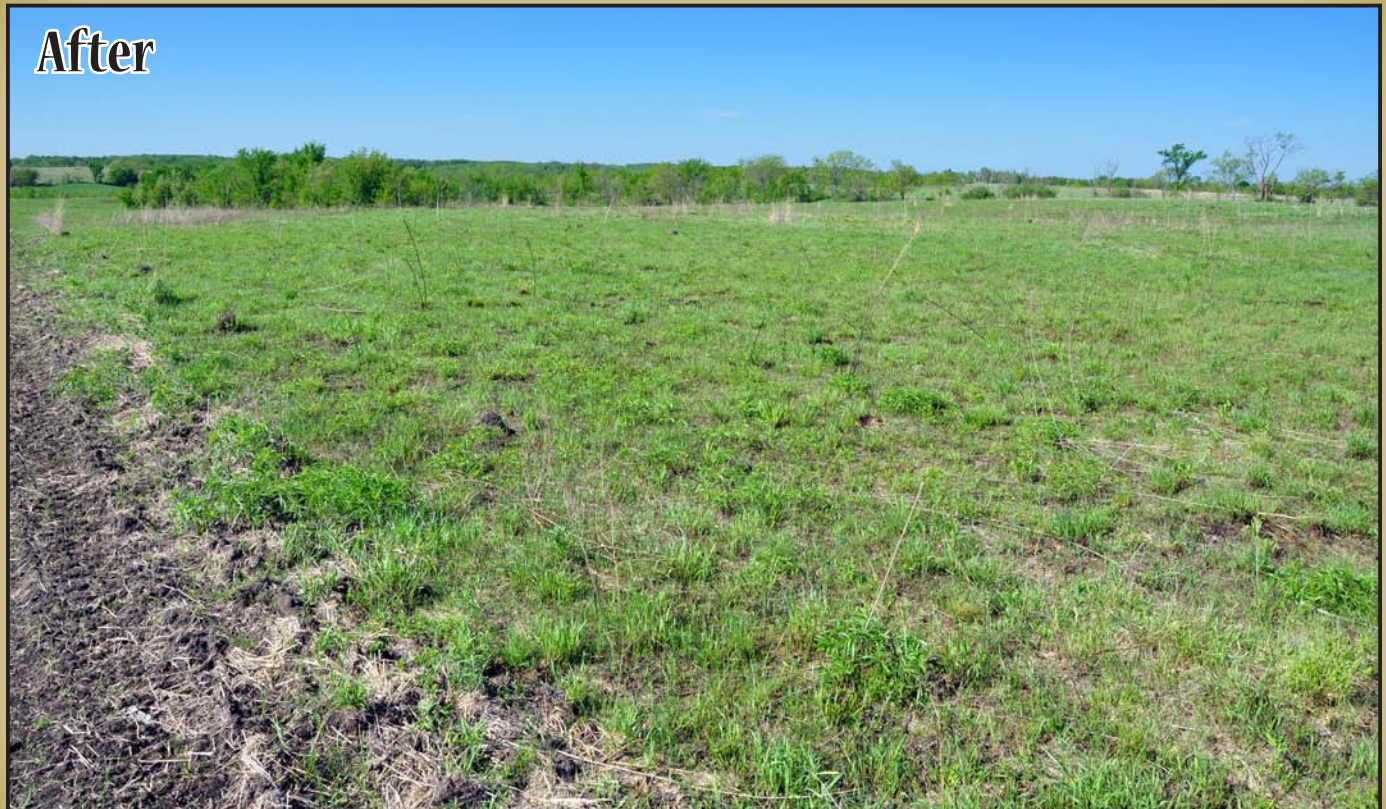
## After

**Success:** Following the burn, the landowner noticed a strong comeback and increased diversity of the forb (native flower) component of the prairie. Prescribed burns also help enhance seed production, control plant disease, and improve wildlife habitat.

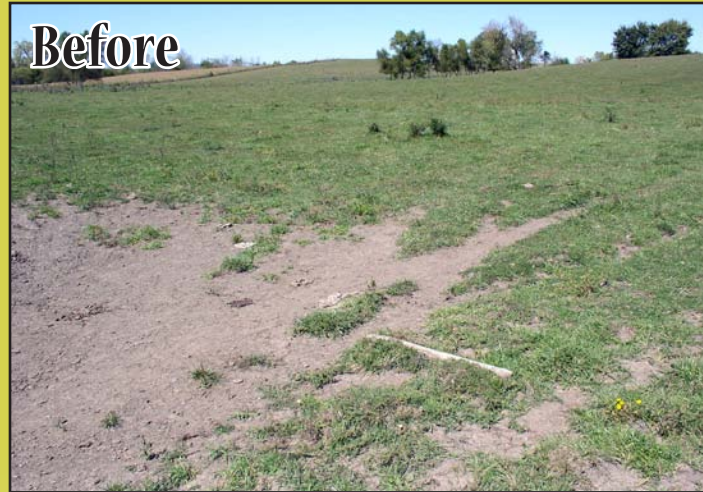
**Before**

With continuously grazed pastures, livestock tend to congregate in areas and form trails, leading to bare, eroded soils. If a farm pond is supplying water, cattle often stand in these areas causing animal health issues and poor water quality.

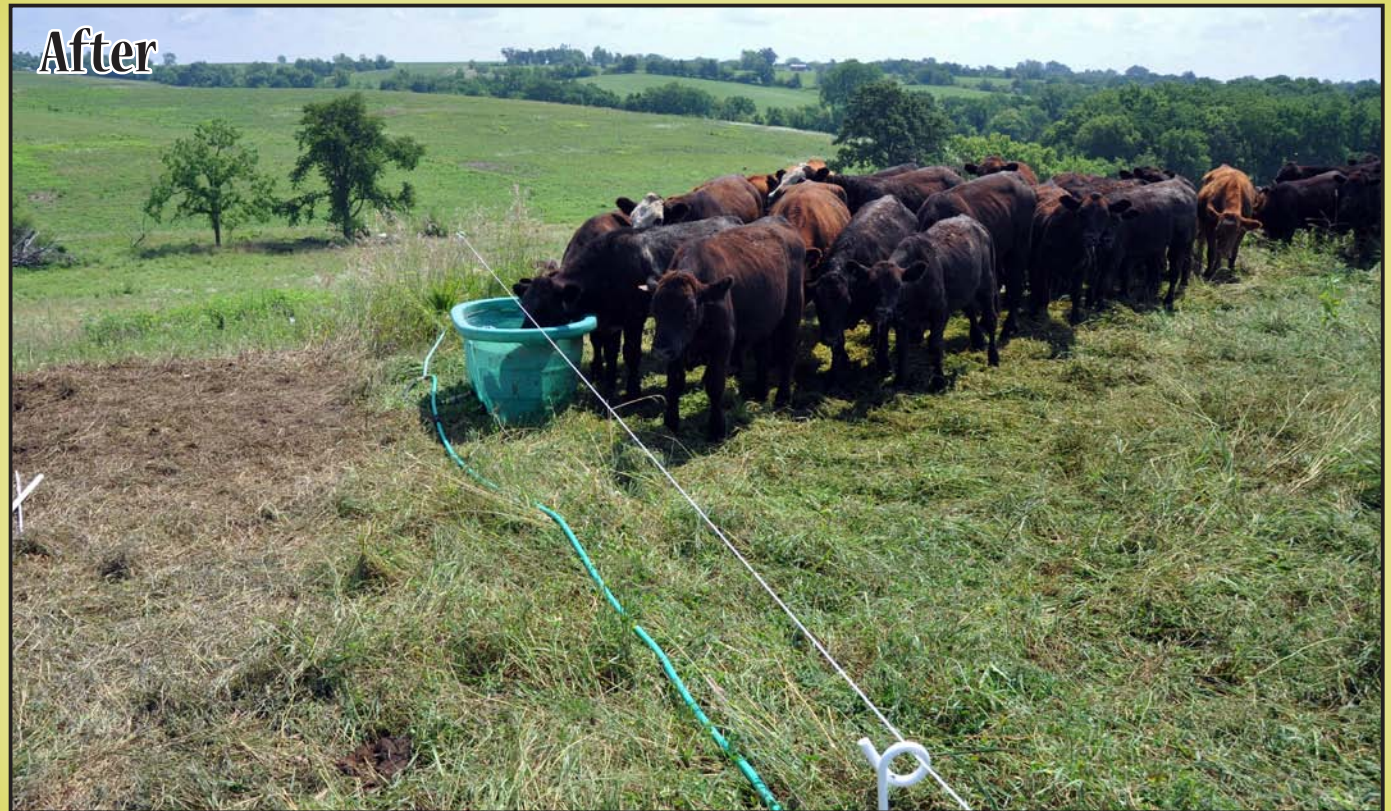
**After**

A Mahaska County father-son grazing operation implemented a grazing system where they successfully graze 100 stockers per acre using temporary fences and move water with the cattle. This type of system allows plants sufficient time to recover and for diverse wildlife and plant species to move in. This system also provides the animals optimal feeding and weight gain.

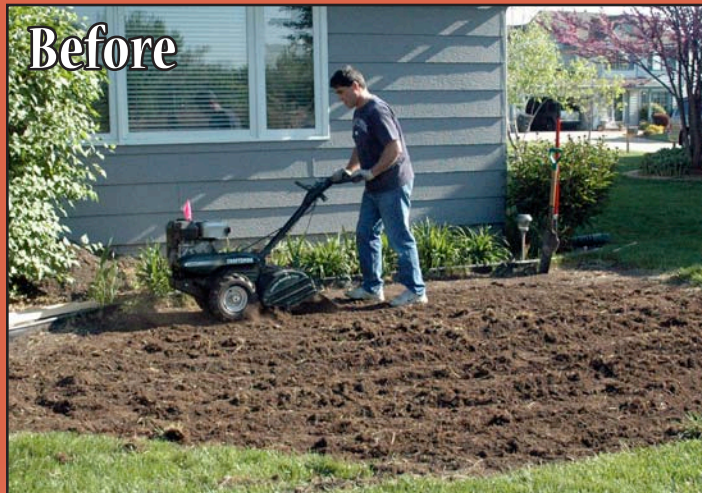
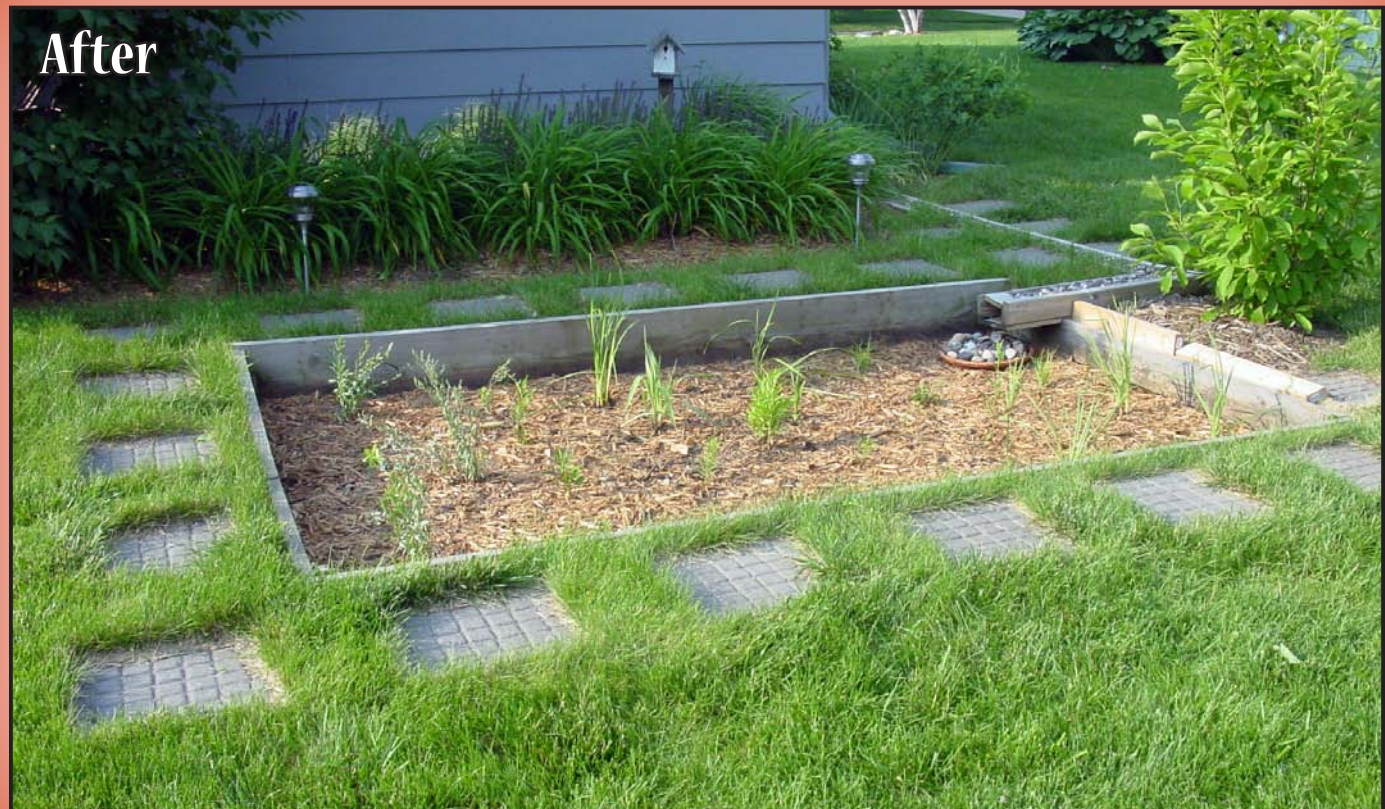
# Rain Garden

**Background:** Like so many suburban homeowners, Paul Miller's yard had areas of ponding following heavy rains. Storm water runoff from impervious surfaces (i.e. rooftops, driveways, patios) carries pollutants like grass clippings, hydrocarbons, and sediment to receiving waters without treatment. Rain gardens are shaped like shallow bowls. They are built with amended soils with high percolation rates and planted with native plants and flowers to capture and infiltrate water before it can reach any water bodies.

**Success:** Miller placed his rain garden in his backyard near enough to the downspout to capture rainwater from his roof. He estimates that about 100,000 gallons of rainwater will flow into his rain garden annually.

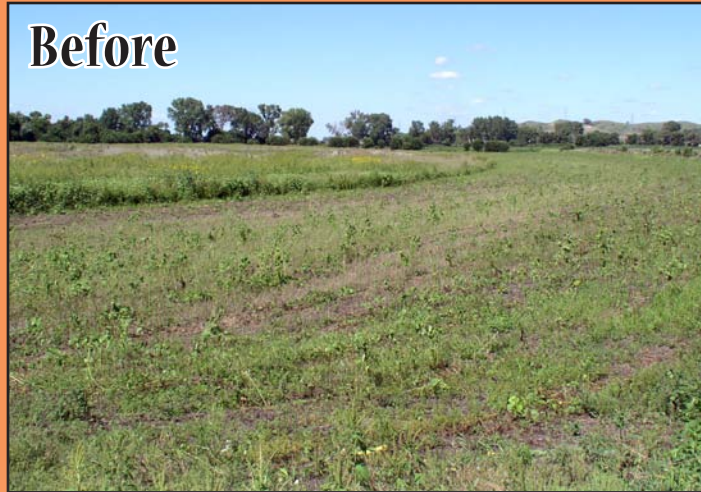
**Before**

Cropland adjacent to the Big Sioux River in northwest Iowa frequently flooded and was eventually used for hayland. By the mid 2000s the land was too wet to even get a solid hay crop.

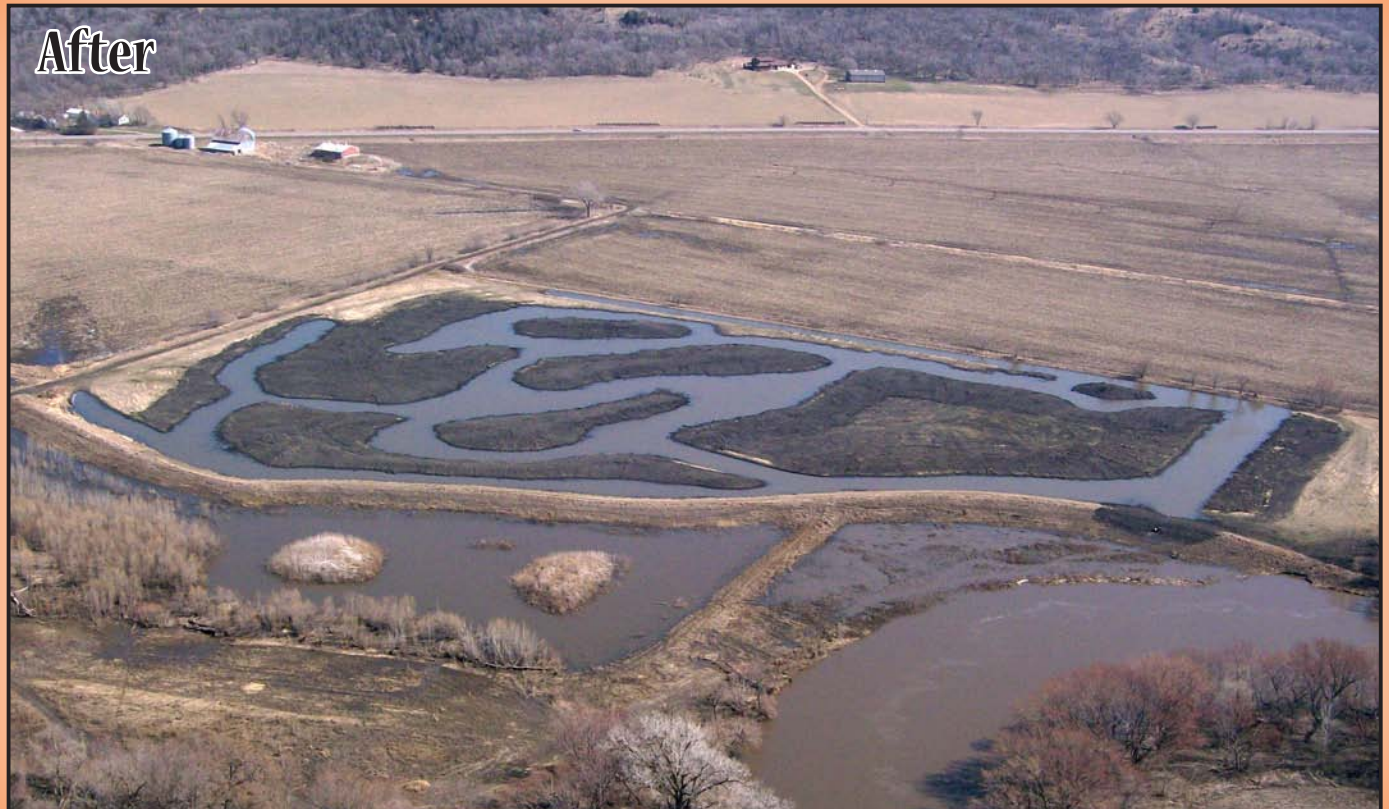
**After**

The landowner transitioned a portion of the ground to wetlands. A new landowner purchased the property and restored the remainder to wetlands through the Wetlands Reserve Program (WRP). The new owner uses the newly created wildlife habitat for hunting. The wetland complex is also used for family recreational outings such as camping and fishing in the adjacent river.

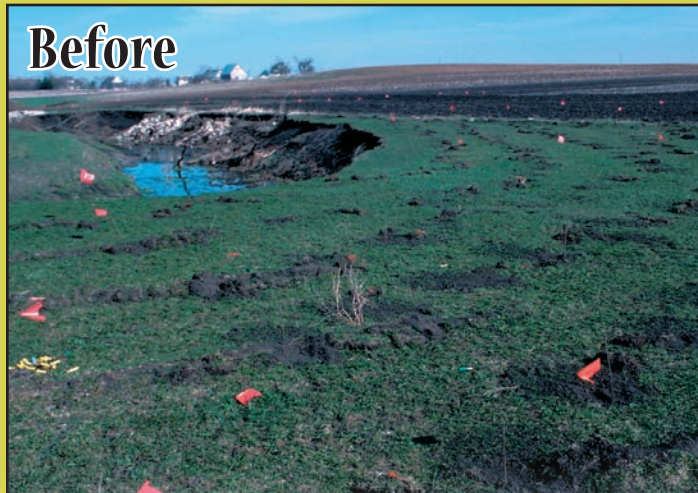
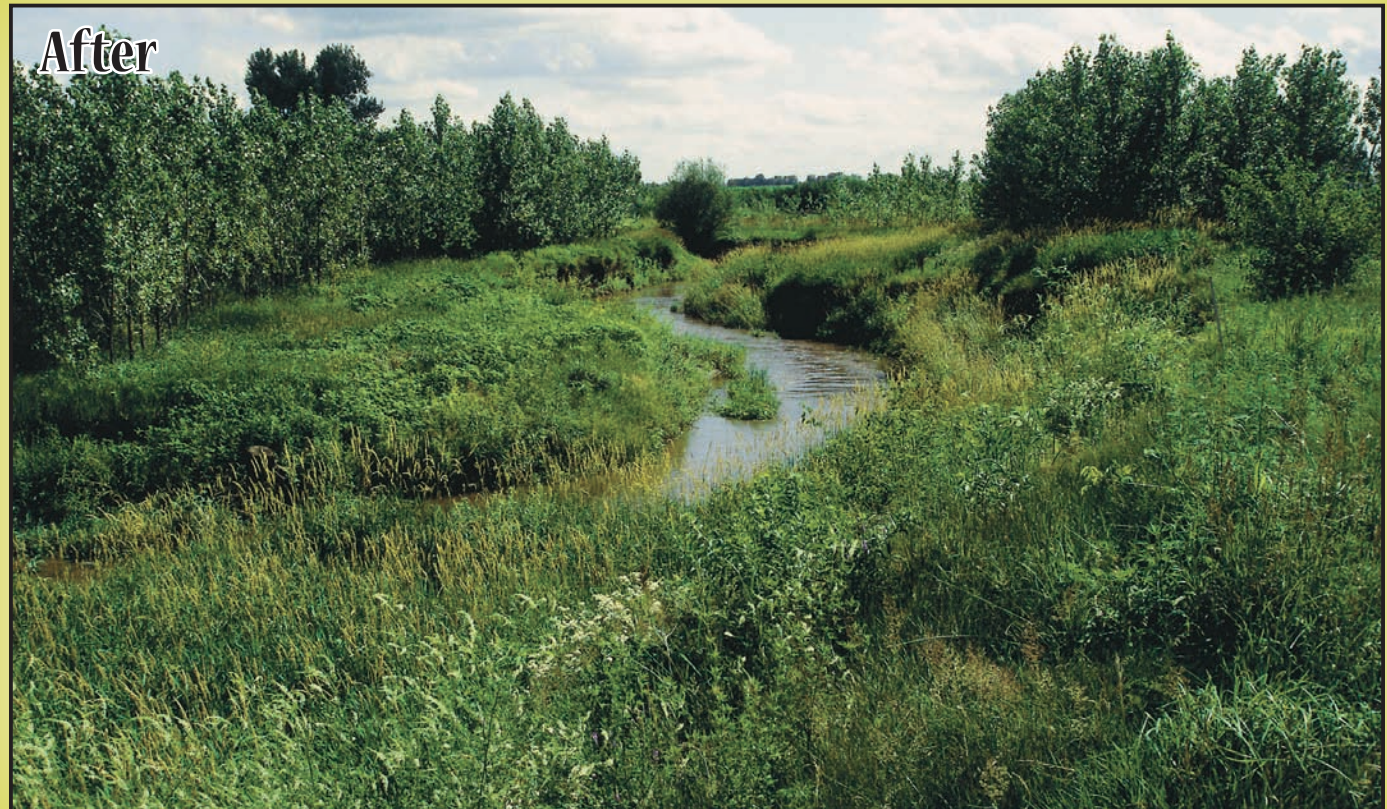
# Riparian Buffer Strip

**Background:** Bear Creek in Story County is much like many streams in Iowa that run through areas of intensive cropping or heavy grazing. The creek's banks had eroded, the creek bottoms were loaded with sediment, and the water quality was degraded by high concentrations of suspended solids, nutrients, and agricultural chemicals.

**Success:** A conservation partnership implemented a restoration plan. The team installed a multi-species riparian buffer strip to reduce the impact of non-point source pollution on the creek. The buffer includes an outside area of undisturbed trees, a middle area of managed fast-growing trees, and a strip of grass along the creek to intercept surface runoff.

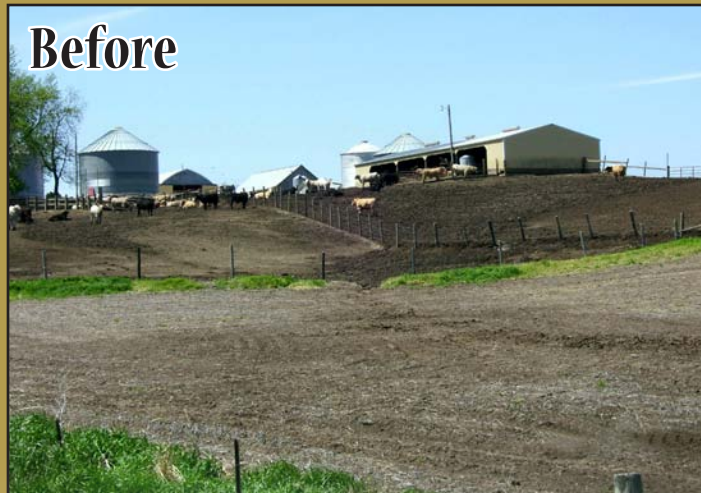
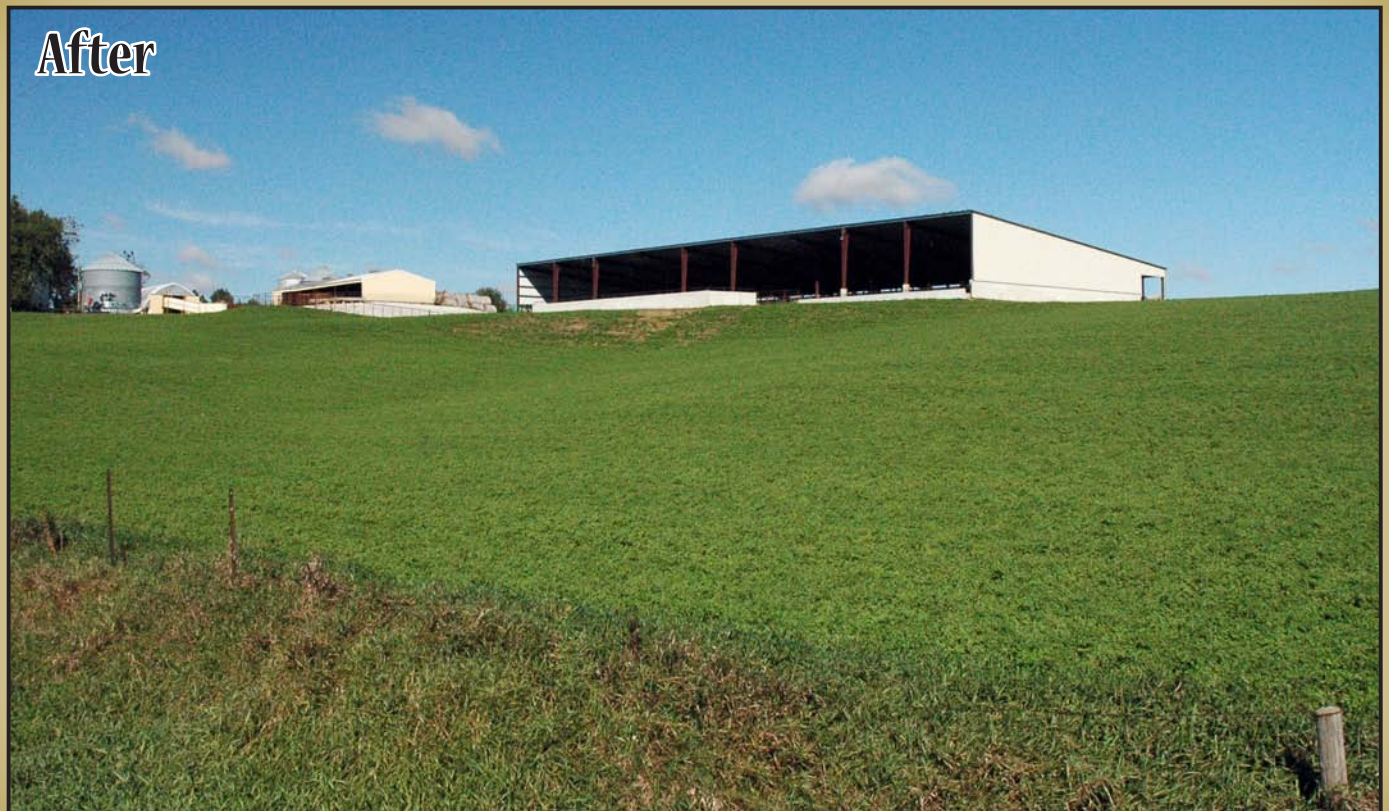
# Steel Roofed Livestock Building

**Background:** Cattleman Clint Sonderman battled manure runoff issues, particularly during spring snowmelt, on his 20-acre feedlot. In October 2008, he installed a 20,000 square foot total containment monoslope building for his 500-head livestock feeding operation. The new building includes three pens and cornstalks for bedding.

**Success:** Sonderman's monoslope building totally eliminates the manure runoff and soil erosion issues he faced with his open feedlot, thus improving water quality in nearby streams. The new facility also allows for better manure utilization and is helping him produce healthier, more productive livestock.

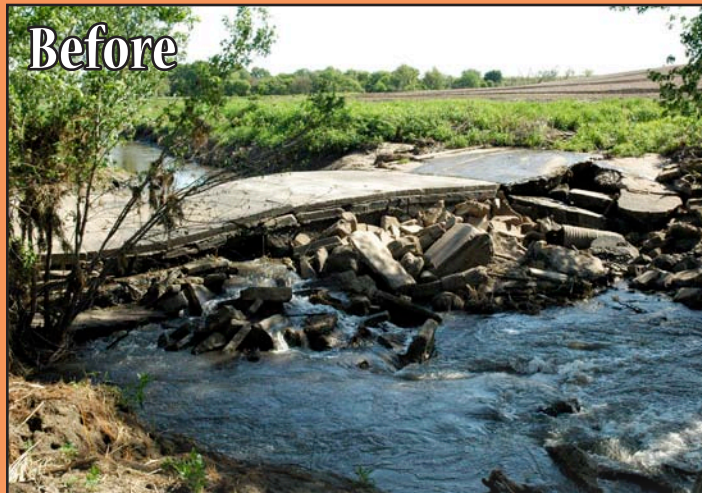
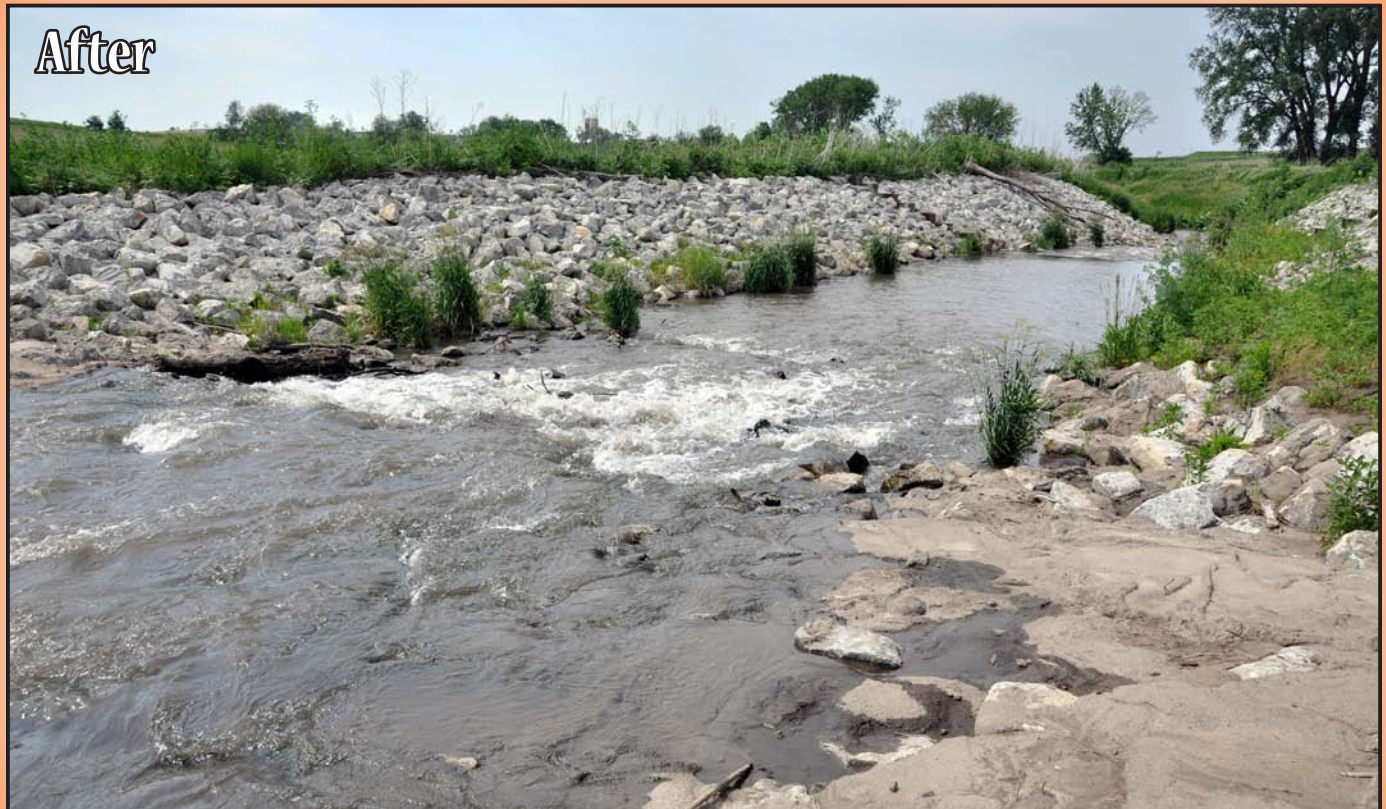
# Stream Crossing/Stabilization

**Background:** There were several reasons and partners with interest in this project. Pottawattamie County needed something done along Jordan Creek to reduce erosion beneath a bridge. That stretch of the creek was also the most unstable, and needed to be stabilized. Additionally, an old stream crossing (left) that allowed a farmer to access his field was ready to collapse.

**Success:** The final Jordan Creek Watershed Project included large-scale streambank stabilization and a new crossing upstream from the old location. This project stabilizes the stream bed and banks along a two mile stretch, and allows the farmer easier access to cropland on the other side of Jordan Creek.

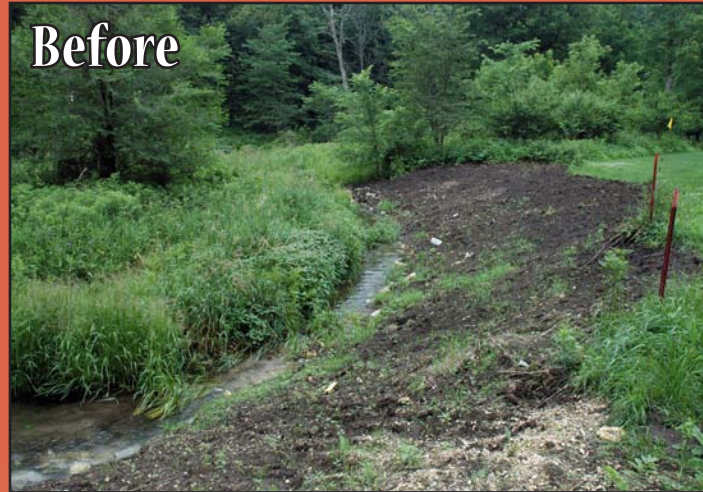
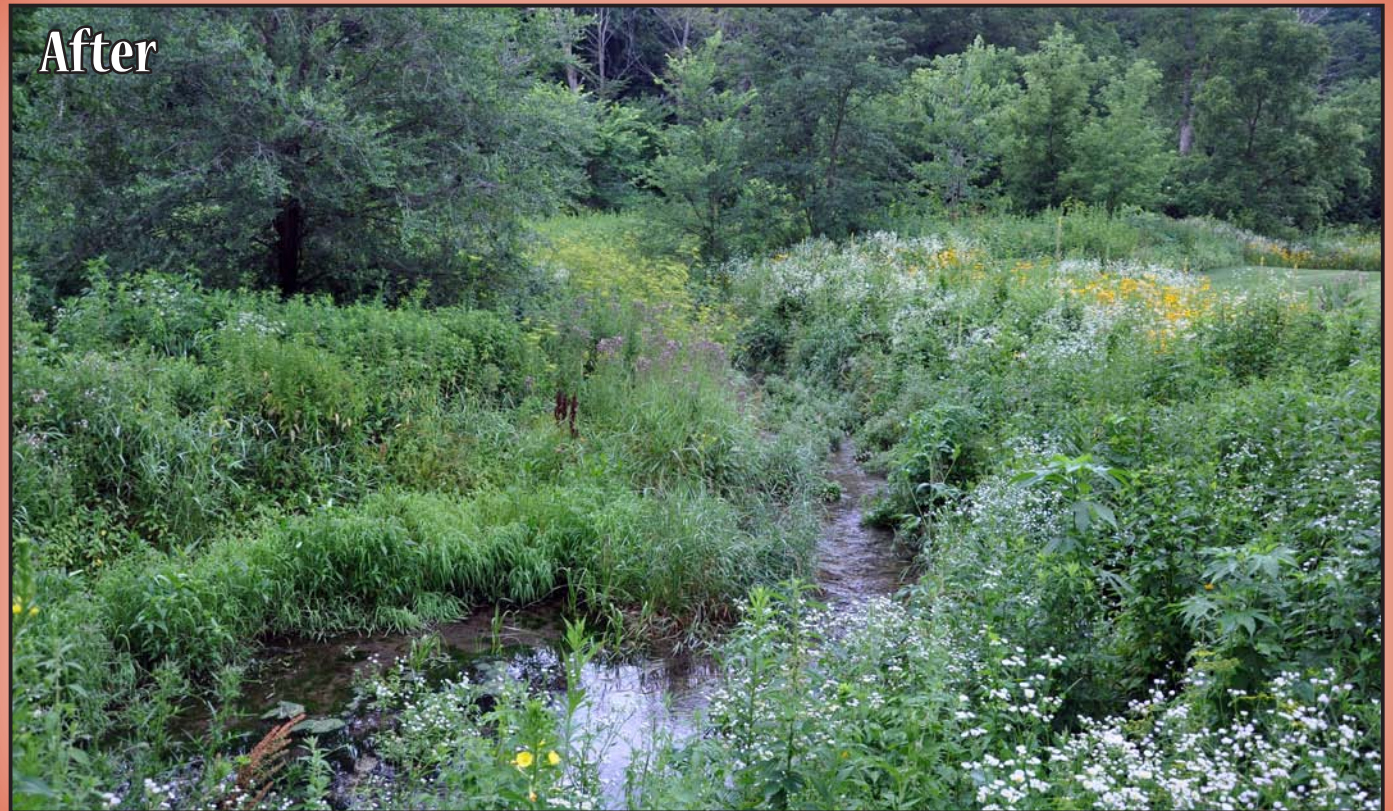
# Streambank Stabilization

**Background:** In the summer of 2010 the non-profit group Seed Savers Exchange™ stabilized 1,915 feet along the banks of a trout stream – South Canoe Creek. The project included removing trees and other brush from the area and reducing the slope of the bank to provide a suitable condition for native vegetation. Rip rap and fish hides were also installed along portions of the stream project.

**Success:** Now that vegetation is established along South Canoe Creek, sediment delivery from stream banks is being reduced. This project is producing a healthier stream through cleaner water for natural brook trout spawning.

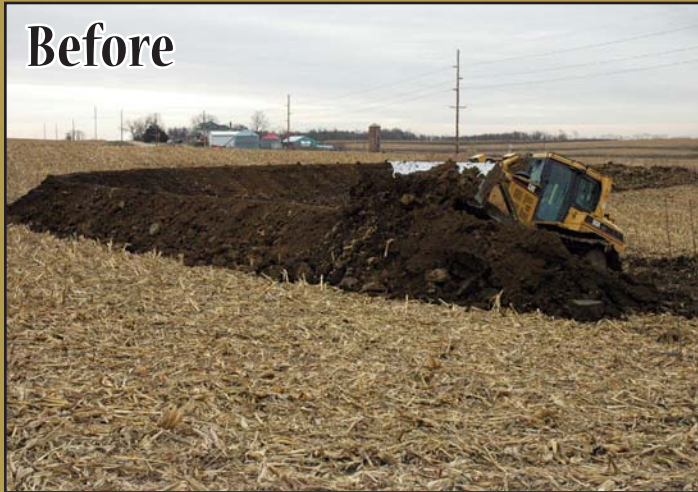
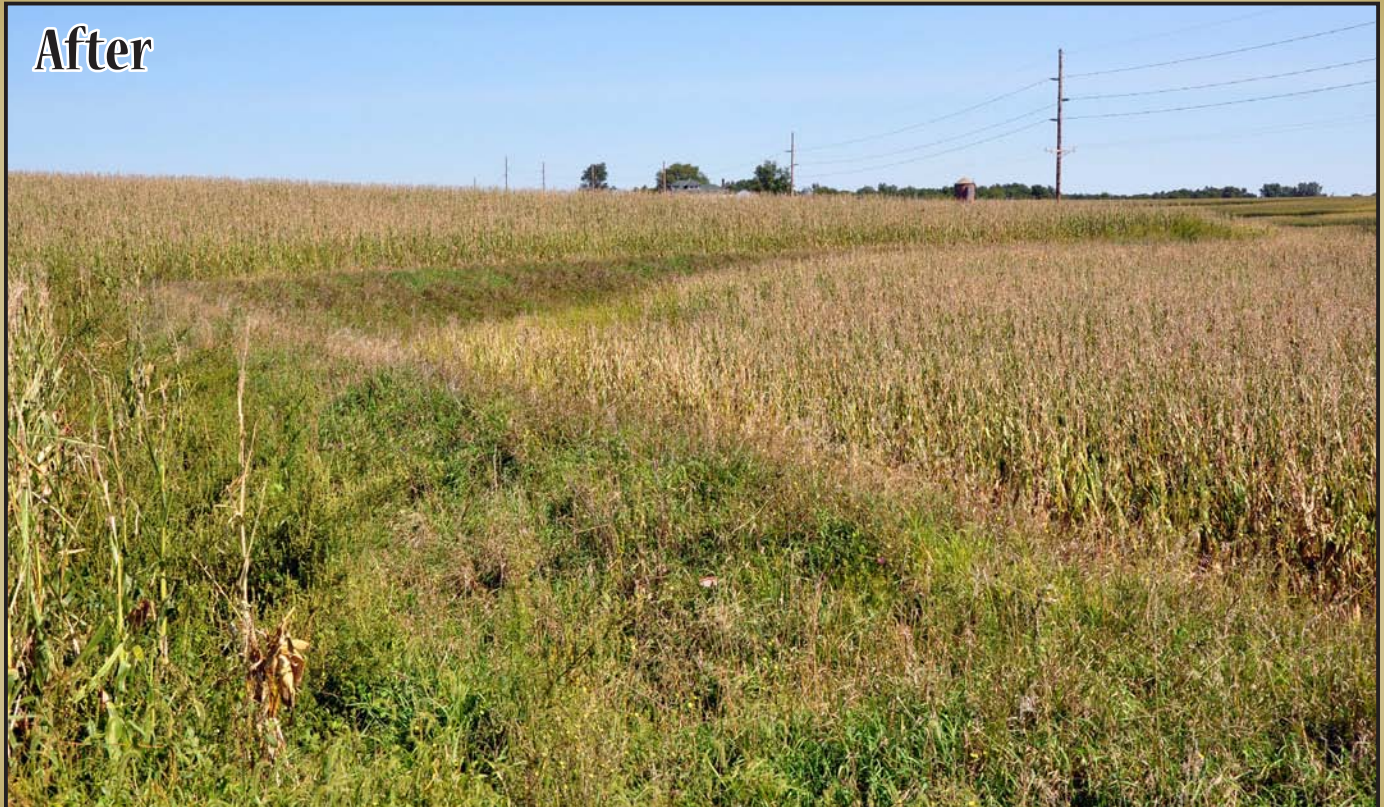
# Terraces

**Background:** Seven Montgomery County landowners in the Hacklebarney Watershed took advantage of special funding on conservation practices through the American Recovery and Reinvestment Act of 2009 (ARRA). This landowner installed tile outlet terraces on cropland that is highly susceptible to soil erosion.

**Success:** The landowner's newly constructed terraces did the job reducing soil erosion during near-record rainfall totals in June 2011. This erosion reduction will ultimately help maintain soil quality and reduce sediment delivery to nearby ditches.

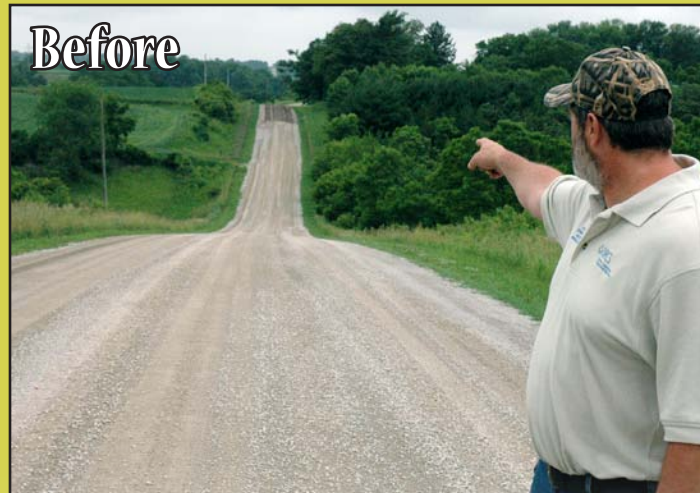
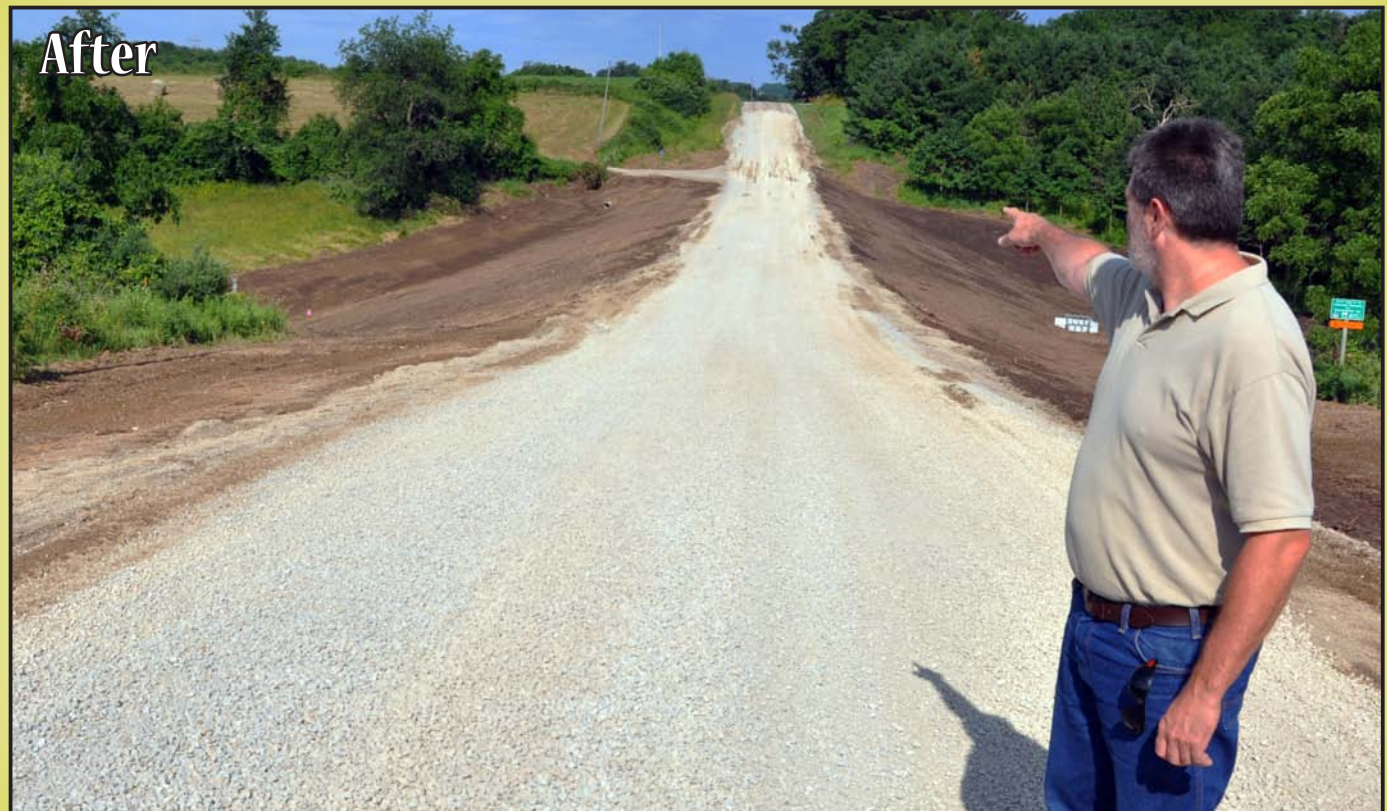
# Watershed Dam/Road Structure

**Background:** Special federal funding in 2009 allowed the Bear Creek Watershed Project to add several new flood control structures. The watershed covers parts of four counties in northeast Iowa and southeast Minnesota.

**Success:** Site 26 is a combination watershed dam and new road structure. The completed structure levels the steep side slopes along the road. That area can now be mowed and the road is safer for traffic and snow removal. The pool area will impound the runoff from a 50-year rainfall event, and a significant amount of damage to local infrastructure is being reduced below this and other new structures in the watershed.
